# Tflex HD80000 Thermal Reliability

This report summarizes the thermal reliability testing of Tflex HD80000. This reliability test procedure is designed to characterize the long term performance of the dispensable thermal gap filler by subjecting the material in the test fixtures to isothermal conditions, repeated thermal shock conditions, and moderate heat and high humidity conditions. The test fixtures feature an isolated sample platform with an area of 12mm x 14mm. Three of these isolated sample platforms are featured on a single test fixture with isolated heating and temperature monitoring for each sample.

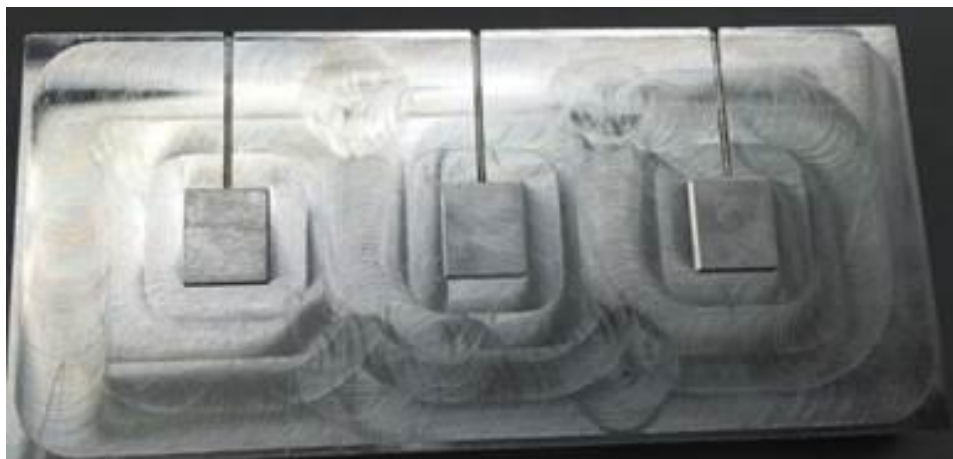
**Figure 1: Test Fixture Hot Plate Sample Surface**

Each assembly, with sample, is tested at time zero and then placed into the conditioned chambers for the specified period of time. Generally, every 250 hours the assembly is removed, tested and then placed back into the chamber. Figure 1 shows a detail of the hot plate surface, providing a visual of the isolated and raised sample platform. See figure 2 for an image of the test fixture with dual fan in place for testing.

The test fixture is a rectangular fixture with dimensions of approximately 2 inches x 5 inches, or 10 square inches. It consists of an aluminum hot plate and an extruded aluminum heat sink. The hot plate has three machined holes at even intervals for insertion of cartridge heaters. Both hot plate and heat sink have three smaller precision machined holes for thermocouples. The thermocouples can be inserted in very close proximity to the surface of the plates and precisely in alignment for each set of “hot” and “cold” thermocouples. The sample is placed on the 12mmx14mm raised pedestals (1.1mm height) on the hot plate surface and the fixture assembly is fastened by two metal straps. Each test fixture accommodates 3 samples of 12mmx14mm. Final testing gap was set by using metal shims of appropriate height to achieve a sample gap of 1.5mm or 4.25mm. During testing, a dual fan unit is placed on top of the aluminum heat sink and air flow is directed from the heat sink to the atmosphere. The completed assembly is operated in an ambient laboratory environment. Once fully assembled, the cartridge heaters are connected to a power supply and power is applied to maintain a hot plate sample temperature of approximately 70°C across the hot plate surface. This is monitored by the data acquisition system. Steady state condition is achieved in approximately forty five minutes to one hour.
